# 2023 Terrytown Outfall Inspection

February 8, 2023

Inspector: Leann Sato, Stormwater Specialist, CFM  
City of Scottsbluff

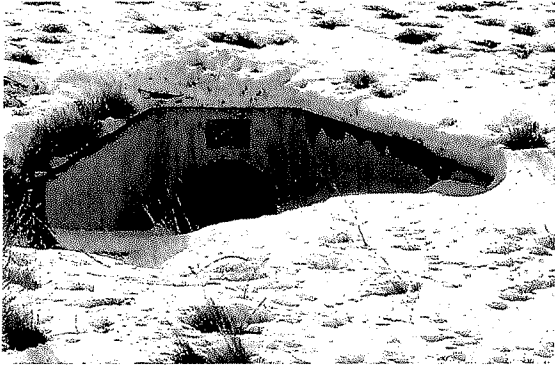
## Outfall 1

**Condition:** Open. Drain path vegetated to river.

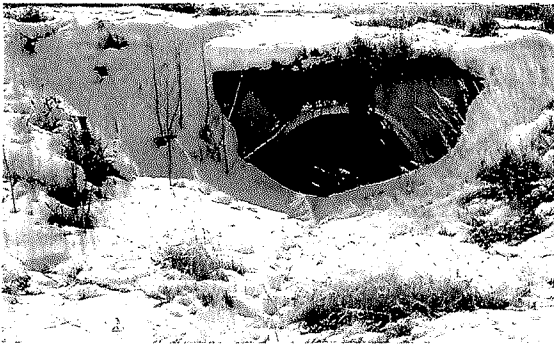
## Outfall 2

**Condition:** Open, flowing into vegetated area before entering Central Canal.

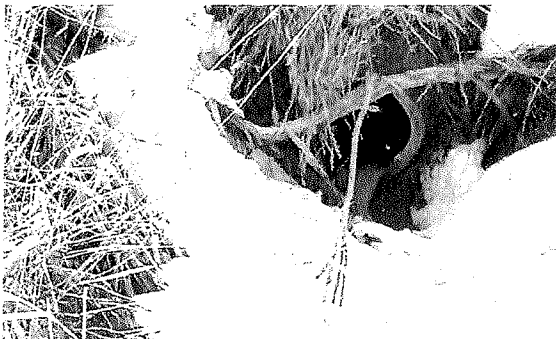
## Outfall 3

**Condition:** Due to snow cover could not see any erosion or if erosion tongue was replaced. If not, continue to monitor bank and under spout for erosion.

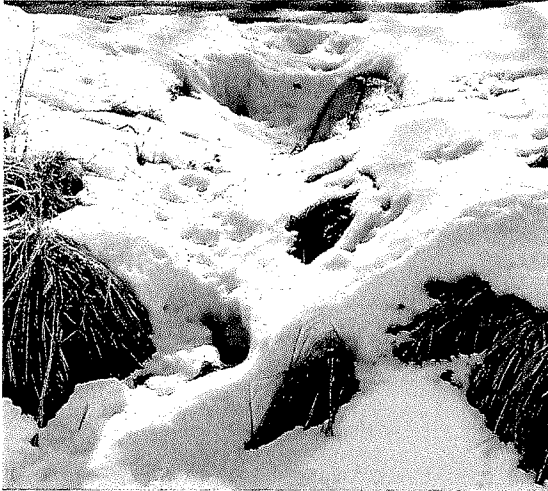
#### **Outfalls 4 & 5 (one opening)**

**Condition:** Snow covered but draining. Unable to see any bank or bed erosion due to snow. Monitor for erosion.

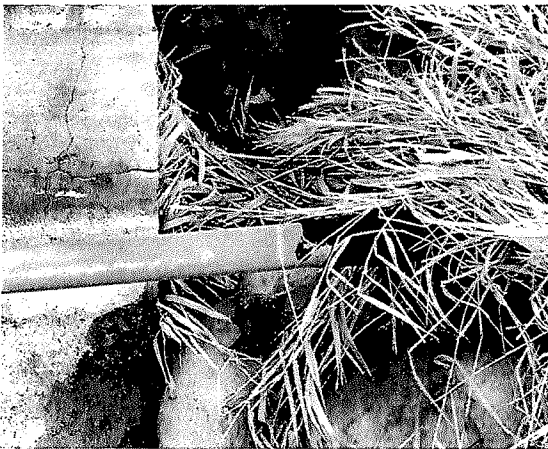
#### **Outfall 6**

**Condition:** Draining but pipe appears semi-clogged. Please flush to re-open.

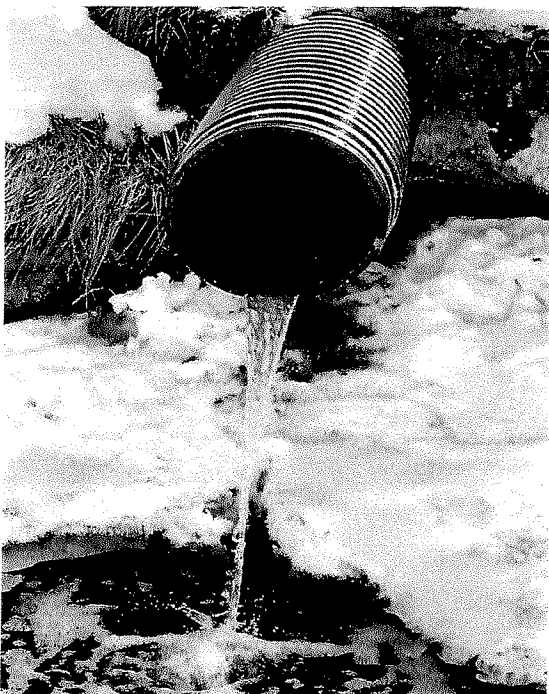
#### **Outfall 7**

**Condition:** Pipe draining well. Extends over channel to prevent bank erosion.

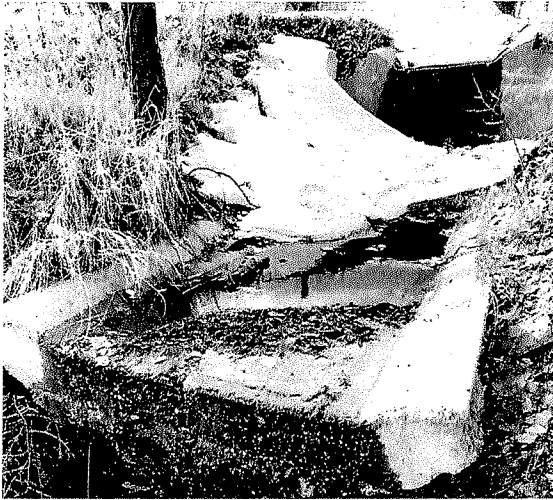
**Outfall 8**

**Condition:** Openings clear and draining.

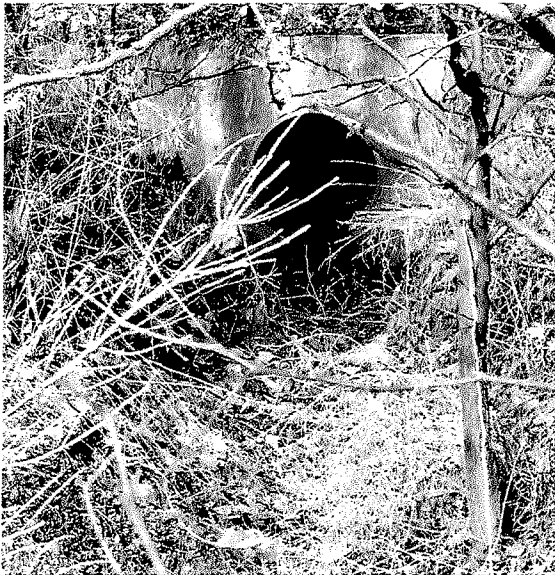
**Outfall 9**

**Condition:** Opening clear and draining. This outfall seems to trap litter from Terry Carpenter Boulevard. May consider litter trap in either inlet or on outfall if regular maintenance is feasible.

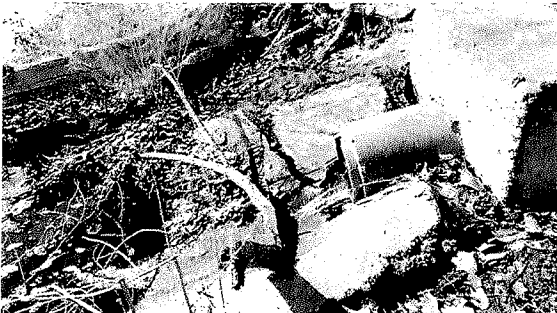
**Outfall 10**

**Condition:** Pipe clear, draining well.

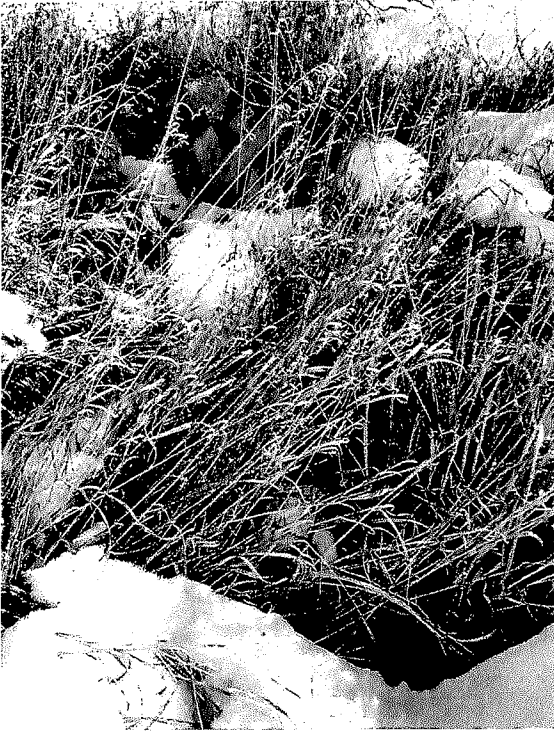
**Outfall 11**

**Condition:** Difficult to see opening due to snow cover, but could hear and see some of the runoff path under the snow.

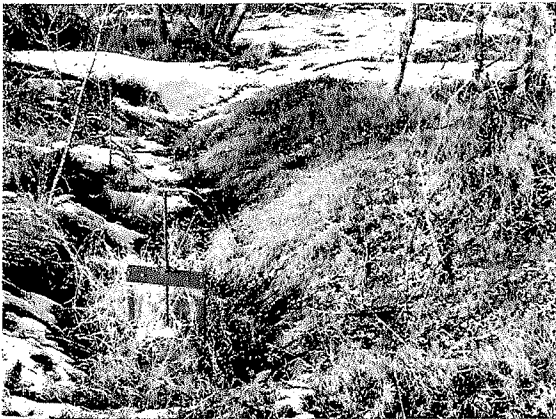
**Outfall 12**

**Condition:** Clear vegetated path to river.
